NBSIR 74-441

Fractographic Examination of Failed Helicopter Tail Rotor Hub Yoke

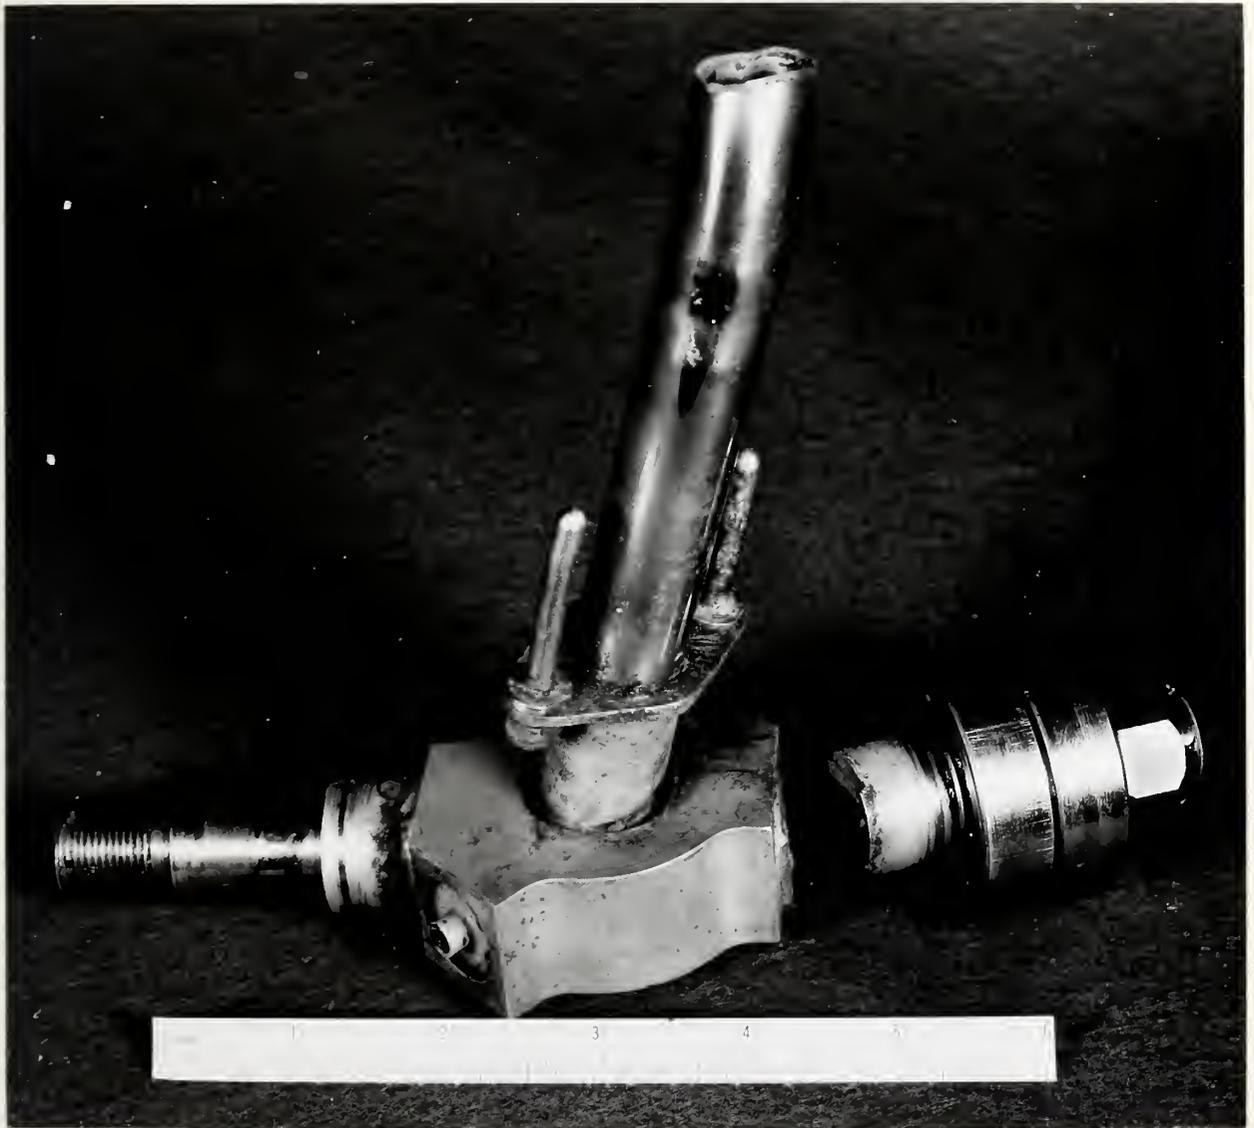
Figure 1. Tail rotor hub yoke as received.

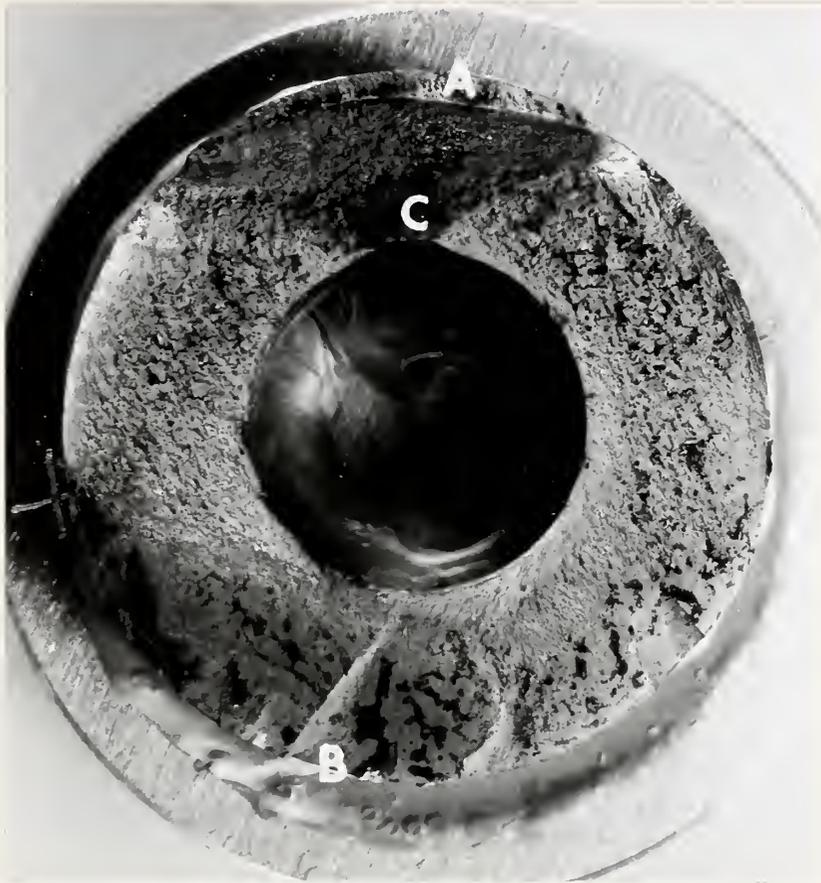
Figure 2. One of the fracture faces. A and B are regions of crack initiation. C is region of overload. X 4

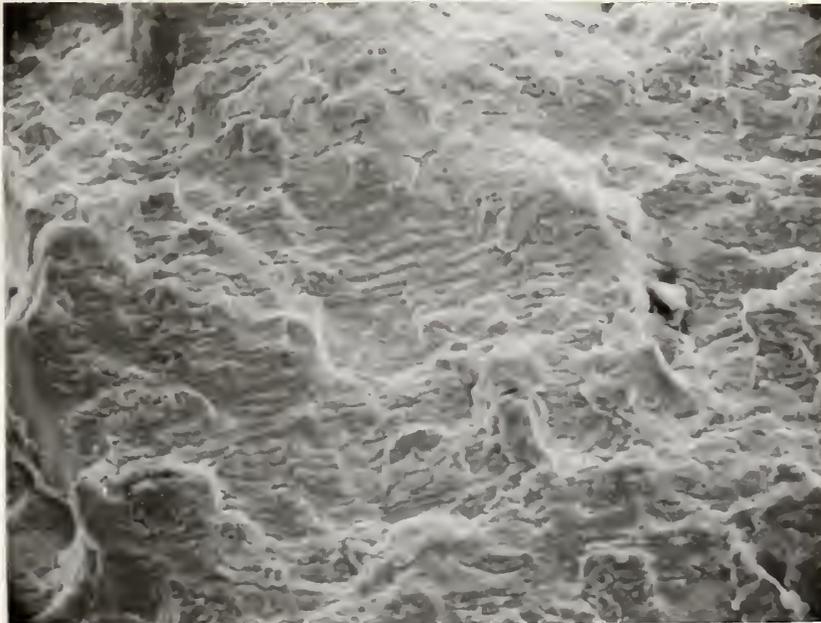
Figure 3. Scanning electron photomicrograph showing strong evidence of fatigue striations on the fracture crack initiating in region B. X 1000

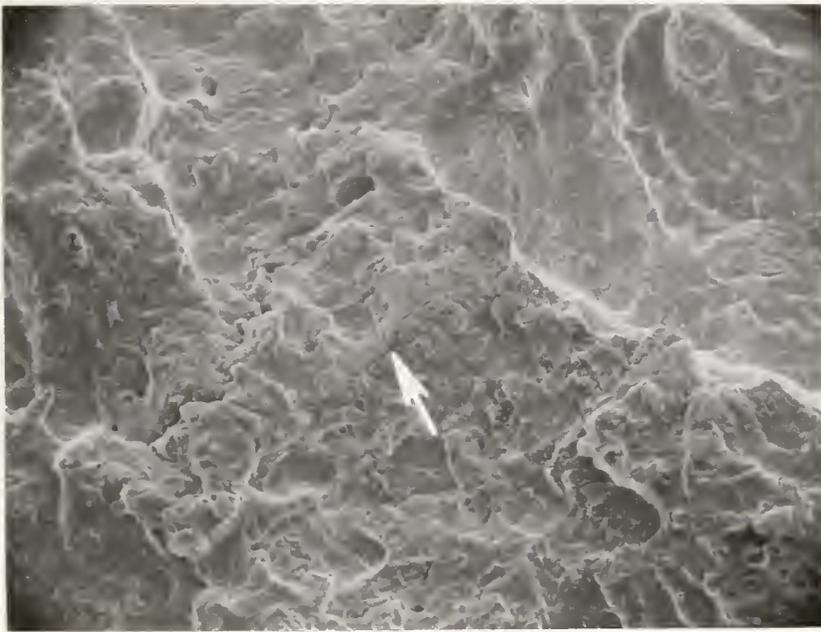
Figure 4.. Scanning electron photomicrograph showing evidence of fatigue striations (arrow) on the fracture crack initiating in region B. X 475

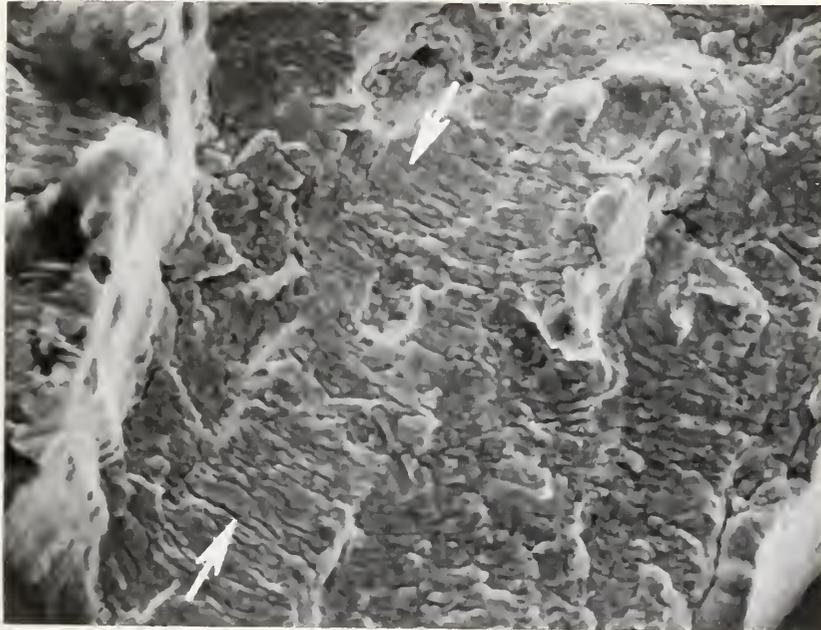
Figure 5. Scanning electron photomicrograph showing evidence of fatigue striations (arrows) on the fracture crack initiating in region B. X 1800

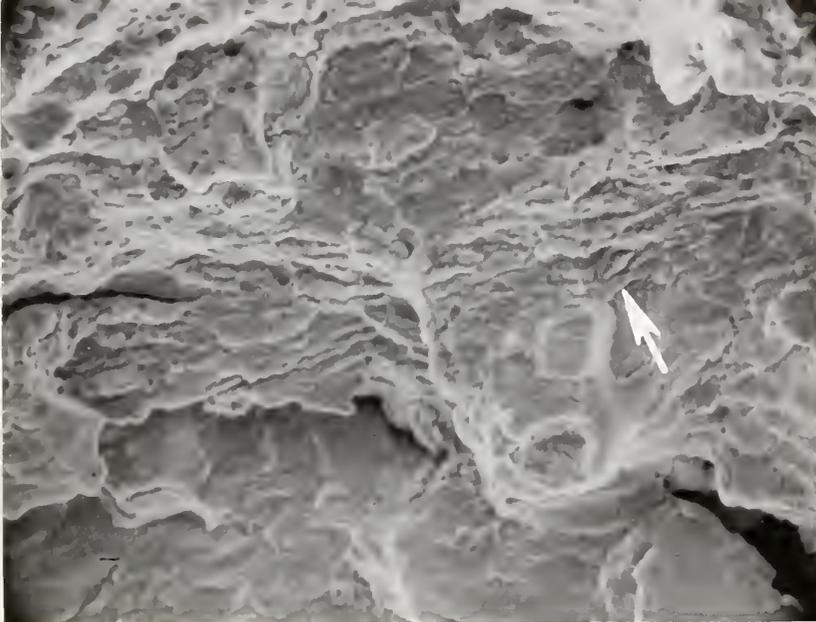
Figure 6. Scanning electron photomicrograph showing weak evidence of fatigue striations (arrow) on the fracture crack initiating in region A. X 1100

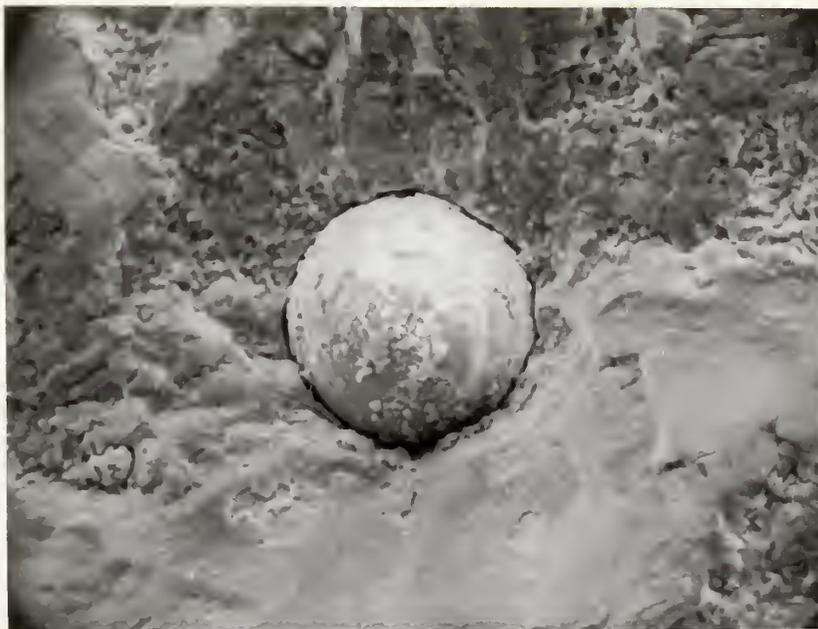
Figure 7. Scanning electron photomicrograph showing large inclusion on the fracture surface near region A. X 1100

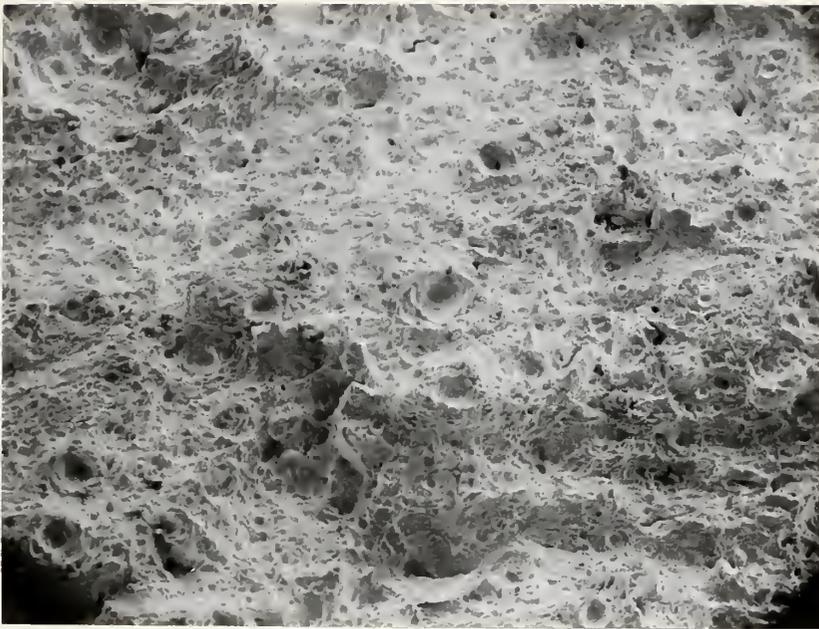
Figure 8. Scanning electron photomicrograph of overload area of the fracture showing porosity and "holes" where inclusions may have been. Dimpled rupture is the primary fracture feature. X 100

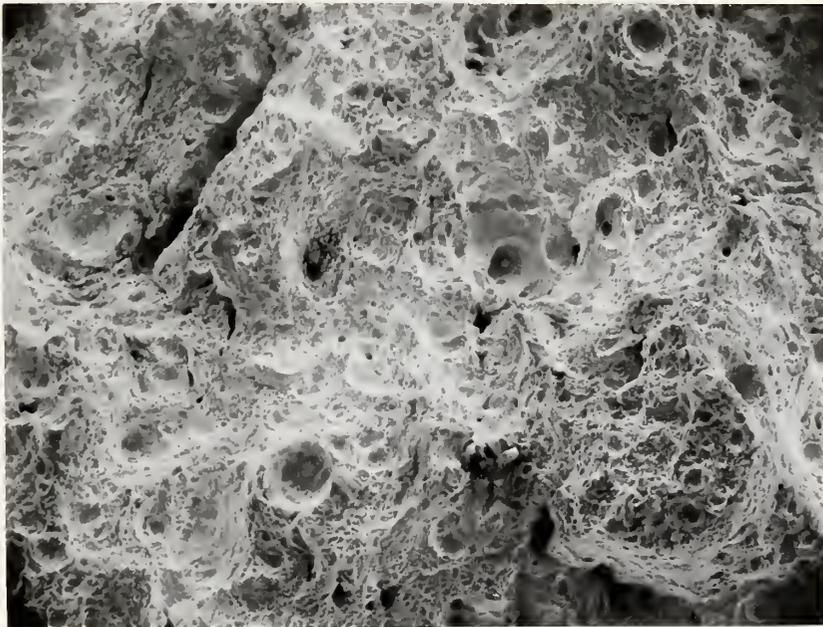
Figure 9. Scanning electron photomicrograph of overload area of the fracture showing porosity and "holes" where inclusions may have been. Dimpled rupture is the primary fracture feature. X 200
